Office of Transport Safety Investigations

BUS SAFETY INVESTIGATION REPORT

FATAL COACH ACCIDENT

BARRENGARRY NATURE RESERVE

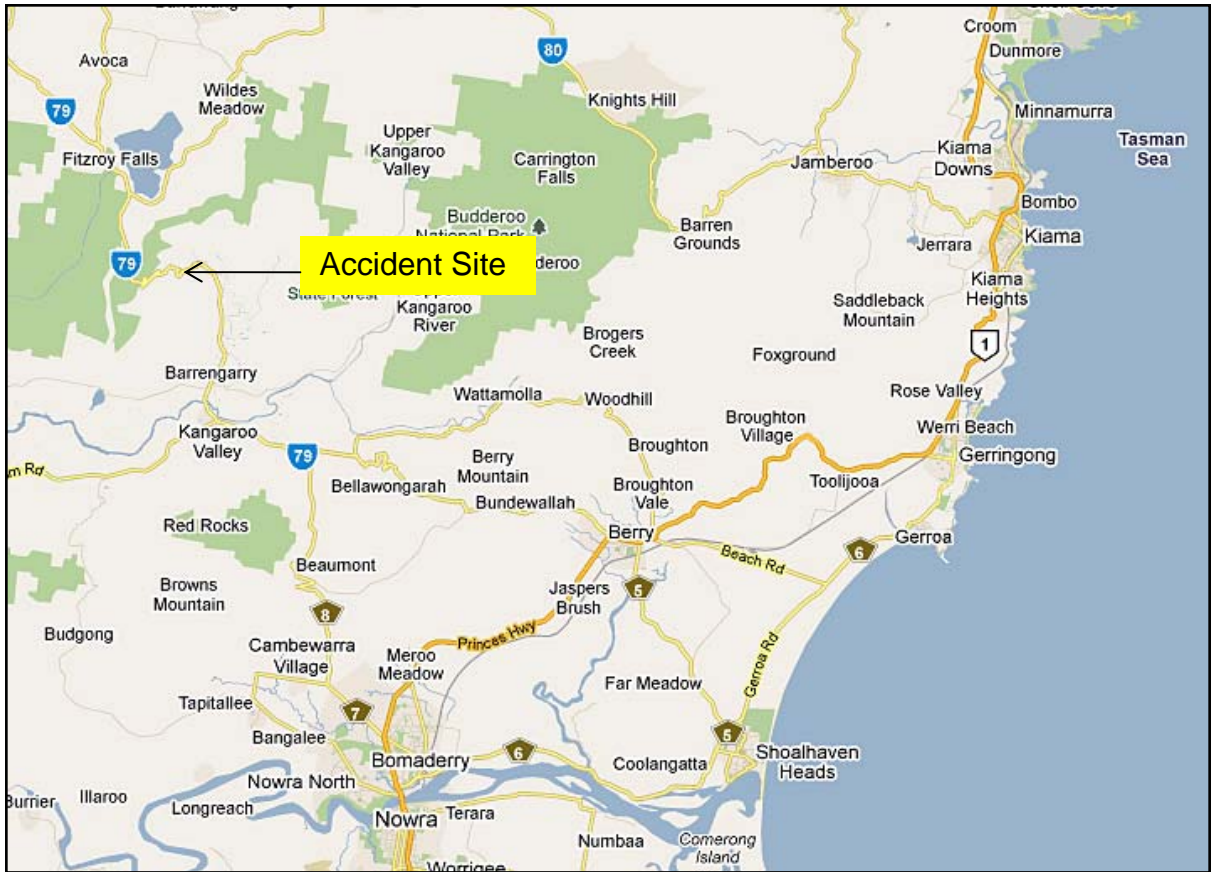
Figure 1: Accident location

- 1.1 At approximately 7:15pm on Friday 14 May 2010, a coach on charter from G&S Mini Bus Pty Ltd (G&S Mini Bus) crashed through the guardrail on a tight curve on Moss Vale Road in the Barrengarry Nature Reserve, approximately 10km South East of Fitzroy Falls (see *Figure 1*). It then continued on through dense bush down a steep embankment, finally coming to rest in an upright position some 40m from the road.
- 1.2 The driver of the coach suffered fatal injuries as a result of the accident and 27 of the 28 passengers were injured, with the condition of three initially classified as critical.
- 1.3 The coach had been chartered by the Polish-Australian Welfare Association, Ashfield, on behalf of a group of 28 volunteer carers for the sick and disabled, to attend an activity in the Kangaroo Valley.

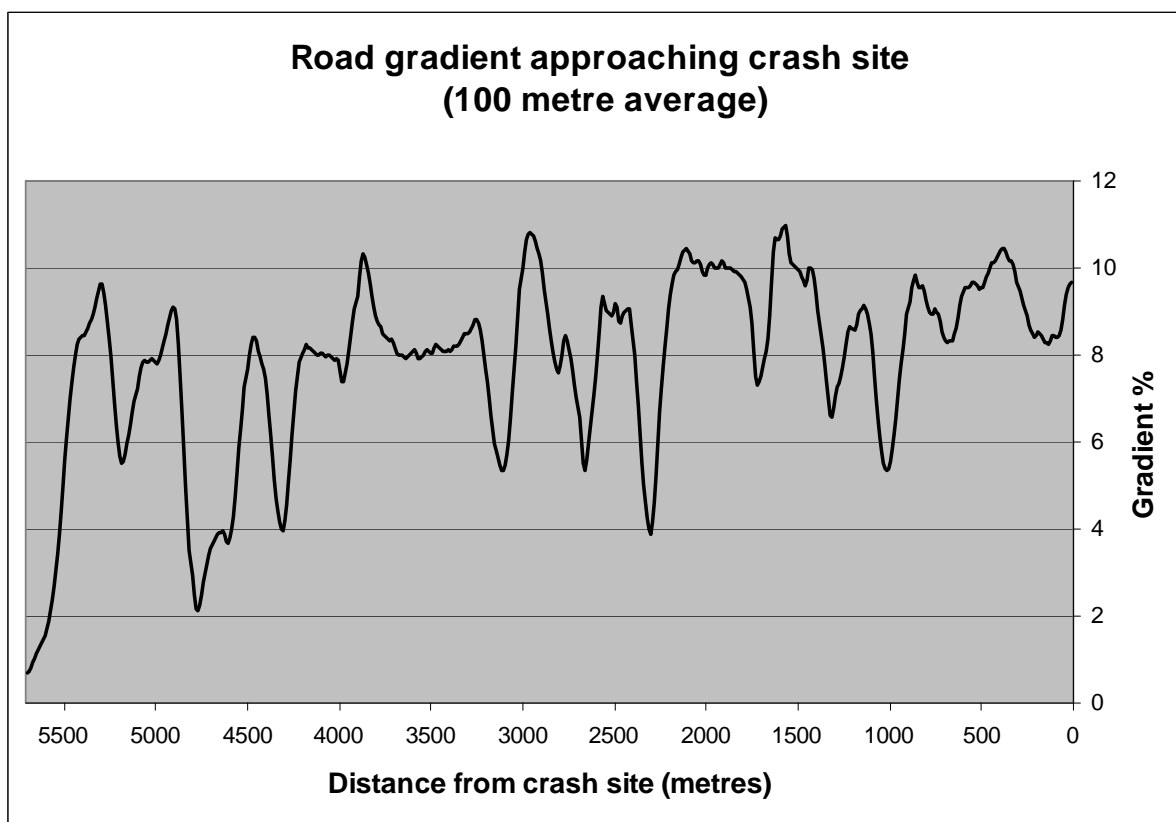
Figure 2: Road gradient approaching crash site

- 1.14 The road between Fitzroy Falls and Kangaroo Valley is a two-way, winding roadway with sharp curves and steep descents. OTSI obtained road mapping information from the RTA, providing gradient measurements every 10m for a distance of 5.8km leading up to the point of the accident. *Figure 2* is a graphical representation of this data simplified by using 100m intervals.

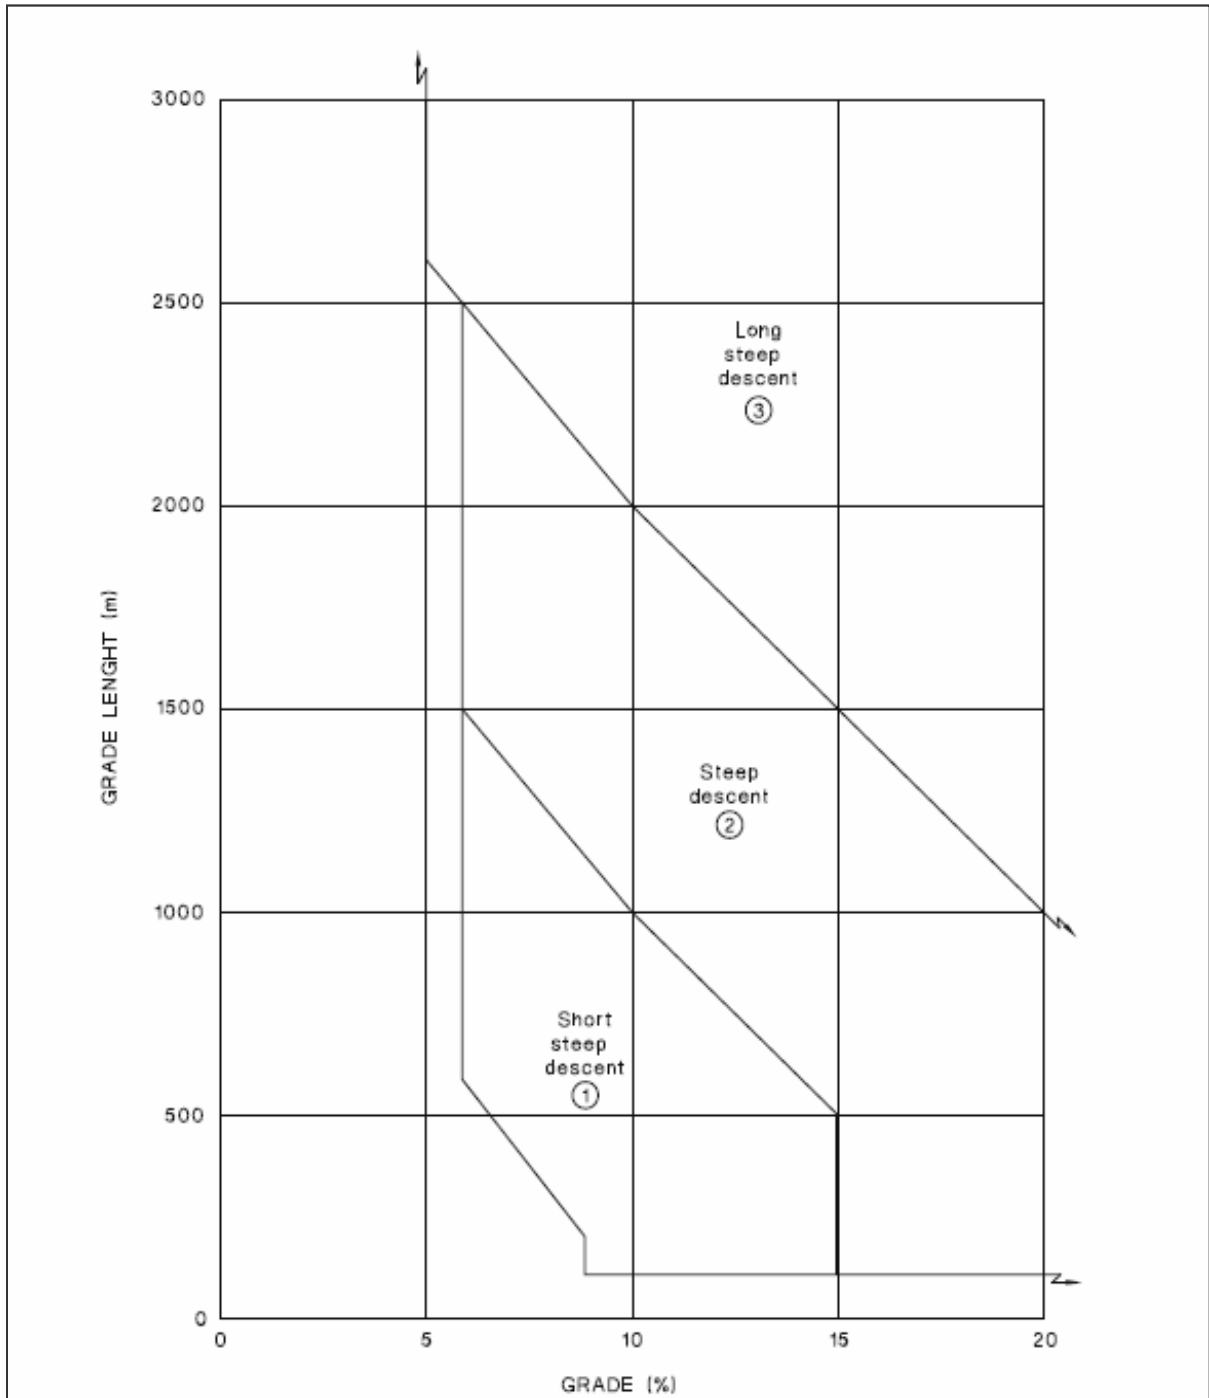
Figure 3: Gradient classification diagram from AS1742.2 - 2009

- 1.15 Australian Standard AS1742.2 - 2009, *Manual of Uniform Traffic Control Devices, Part 2 Traffic Control Devices for General Use*, includes a diagram for use in the classification of road gradients (see *Figure 3*).¹

- 1.16 The section of road leading to the crash location meets the parameters for classification as a “Long Steep Descent”. The appropriate signage would be that shown in *Figure 4*, used in advance of the descent, and supplemented with the sign shown in *Figure 5*, indicating that trucks and buses must use a gear low enough to control the speed of the vehicle without use of the brakes.

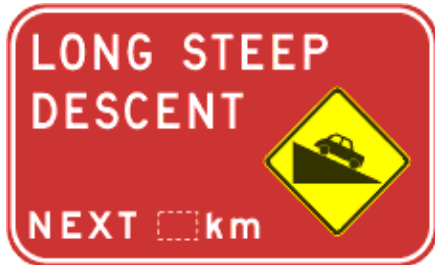
Figure 4: Long Steep Descent sign

1.17 In other areas similar to the Barrengarry area, signs are used to warn drivers of heavy vehicles to engage low range and to travel with caution. On the Moss Vale Road from Fitzroy Falls to Kangaroo Valley there are no signs to warn drivers of heavy motor vehicles to engage a low gear. The only sign that signifies a steep gradient ahead is one sign positioned just prior to the start of the steep section.

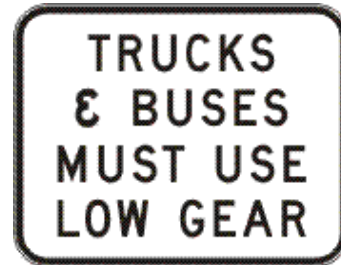
Figure 5: Sign requiring use of low gear

This sign must also stipulate the distance for which the restriction applies, or must be paired with an “END TRUCK & BUS LOW GEAR AREA” sign.

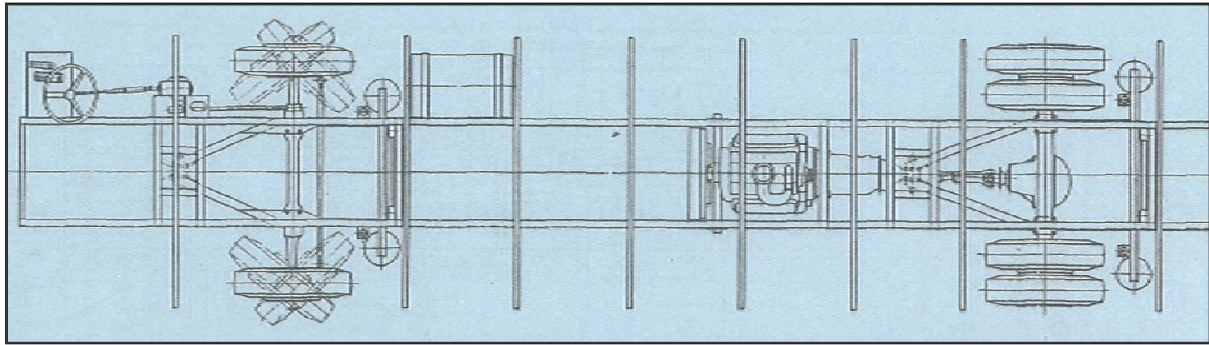
Figure 6: Schematic of coach chassis

- 1.36 The coach's chassis was manufactured by Motor Coach Australia in June 1986 as a two axle vehicle with a GVM of 16,000kg (see *Figure 6*). The Austral Starliner² body was built by Austral Group Manufacturing. The vehicle was authorised to carry 53 seated occupants and to stand 19 (see *Figure 7*). The engine was a centre mounted Cummins LT10-250 six cylinder in-line four stroke diesel. When the vehicle was first built it was fitted with a manual Spicer SST six speed transmission, but this was later changed to an Allison MTB 647 automatic.

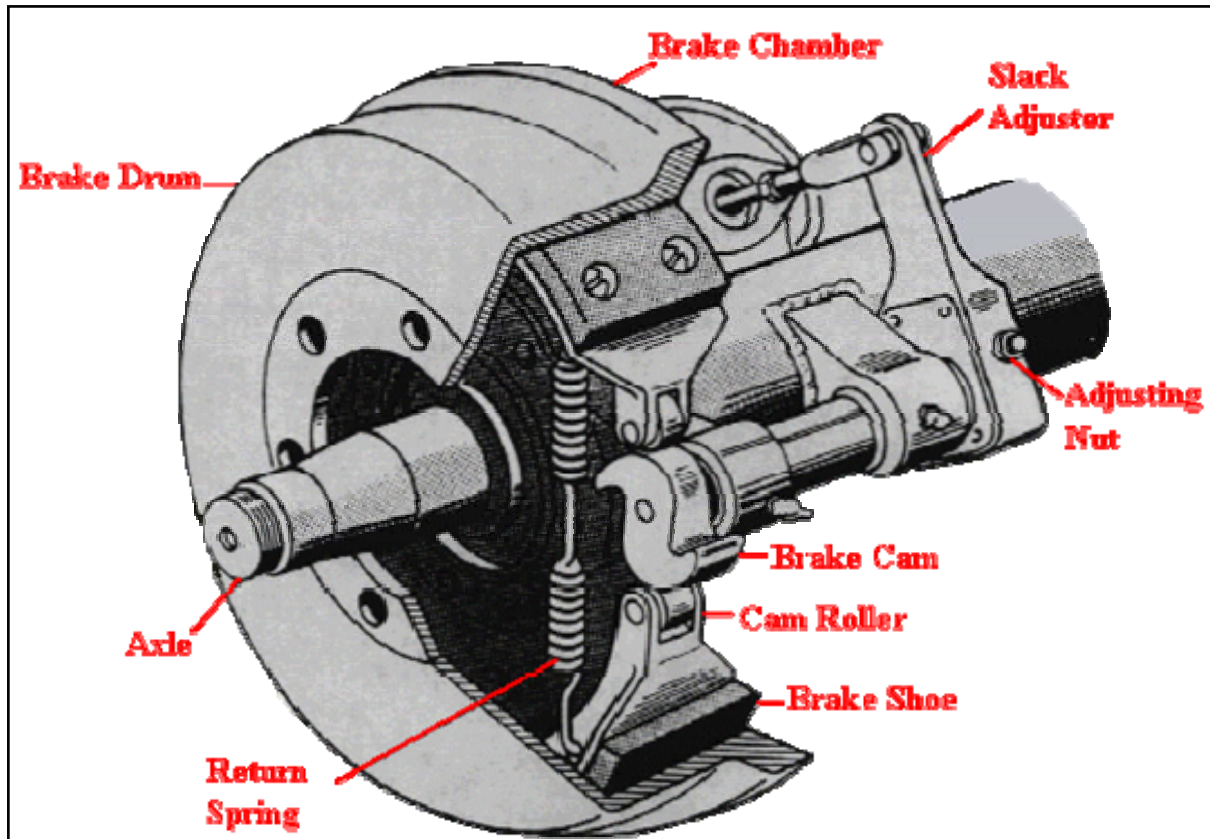
Figure 8: Rear brake assembly

1.42 The coach was fitted with S-cam type drum brakes (see *Figure 8*). Brake adjustment, required at regular intervals in order to maintain effective brake operation, was performed manually, unlike in later model vehicles from the mid-nineties where automatic adjustment was generally provided.

1.43 As the rear axle of the coach was designed to carry more than 60% of its laden mass, the rear brakes were intended to supply the majority of the vehicle's braking effort. In the event of the rear brakes becoming ineffective, an excessive proportion of the vehicle's braking effort would have to be performed by the front brakes. Since the contribution of the front brakes is limited by the proportion of the vehicle's mass carried by the front axle, total braking effectiveness is reduced and the front brakes tend to overheat with extended use. This eventually results in the front brakes becoming ineffective ('fading') and the vehicle becoming a runaway.
